Legionella Risk Assessment

23 Newhaven Court, Nantwich, CW5 5GT

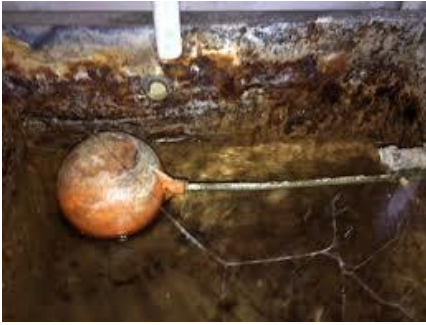
[Fig 1](#)

| Cold Water Storage | | <i>Basement > Utility</i> | Failed | 5.1 |
| Non-insulated plastic tank | | | | |
| Actions * Ensure the tank lid is present and well fitting * Check the tank water temperature remote from the ball <i>Urgent by 2017-11-24</i> | Compliances - None Non Compliances - Visible debris - Tank uninsulated | (Fig 1) | | |

| Risk Category | Actions | Compliance | Priority |
|---|---|---|---|
| Cold Water Storage Basement > Utility <i>GENERAL ITEMS</i> | * Ensure the tank lid is present and well fitting * Check the tank water temperature remote from the ball | Failed | Urgent 2017-11-24 |

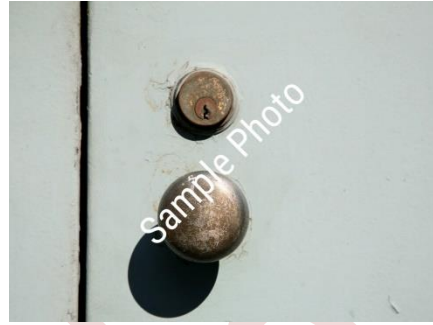
[Fig 2](#)

| Location | Reason | Photo |
|---|---|---|
| Basement > All Rooms | Locked door <i>Here are some supplementary comments about the item.</i> | (Fig 2) |

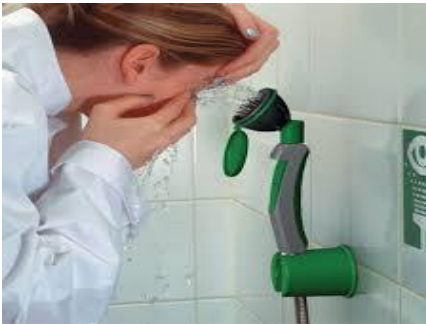
[Fig 3](#)

| Eye Wash Sprays | | <i>Whole Building</i> | Failed | 4.1 |
| <p>Actions</p> <p>* Ensure eyewash spays are flushed through and purged to drain every six months or more frequently if recommended by manufacturers</p> <p>* Place eye wash sprays in areas where there is a risk of eye contamination</p> <p><i>Essential</i> by 2017-11-19</p> | <p>Compliances</p> <p>- None</p> <p>Non Compliances</p> <p>- Eyewash spays are NOT flushed through and purged to drain every six months or more frequently if recommended by manufacturers</p> <p>- Eye wash are NOT located at a central focal point in areas with high risk of eye injuries</p> <p>- Eye wash sprays are NOT protected from dust</p> | <p>(Fig 3)</p> | | |

| Risk Category | Actions | Compliance | Priority |
|---|---|---|---|
| Eye Wash Sprays Whole Building <i>COMMERCIAL ITEMS</i> | * Ensure eyewash spays are flushed through and purged to drain every six months or more frequently if recommended by manufacturers * Place eye wash sprays in areas where there is a risk of eye contamination | Failed | Essential 2017-11-19 |

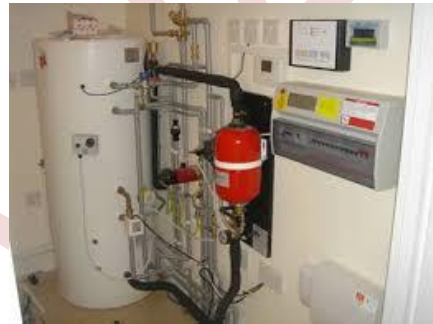
[Fig 4](#)

| Hot Water Storage | | <i>Basement > Utility</i> | Borderline | 5.2 |
| Elson tank 110 litres | | | | |
| Actions * Take measures to ensure temperature is above 50 degrees Celsius <i>Urgent by 2017-11-24</i> | Compliances - No lime scale deposits Non Compliances - Visible corrosion | (Fig 4) | | |

| Risk Category | Actions | Compliance | Priority |
|---|---|---|---|
| Hot Water Storage Basement > Utility <i>GENERAL ITEMS</i> | * Take measures to ensure temperature is above 50 degrees Celsius | Borderline | Urgent 2017-11-24 |

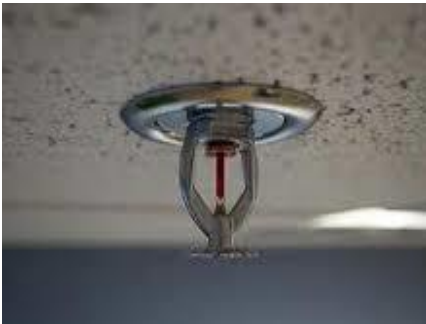
[Fig 5](#)

| Eye Wash Sprays | | <i>Whole Building</i> | Failed | 4.1 |
|---|---|---|---|---|
| Sprinklers | | <i>All Floors</i> | Failed | 4.2 |
| <p>Actions</p> <p>* All fire sprinkler systems should be maintained on a regular basis to ensure they are working effectively and safely to industry standards</p> <p><i>Urgent</i> by 2019-03-11</p> | <p>Compliances</p> <p>- None</p> <p>Non Compliances</p> <p>- Sprinkler systems are NOT maintained on a regular basis to ensure they are working effectively and safely to industry standards</p> | <p>(Fig 5)</p> | | |

| Risk Category | Actions | Compliance | Priority |
|---|---|---|---|
| Sprinklers All Floors <i>COMMERCIAL ITEMS</i> | * All fire sprinkler systems should be maintained on a regular basis to ensure they are working effectively and safely to industry standards | Failed | Urgent 2019-03-11 |
